## The Immense Cost of Japanese Dams and Dam-Related Landslides and Earthquakes [Chinese text available] ダムと地すべりに浪費される巨費 まさのあつこ

Atsuko Masano

Translated by Aaron Skabelund

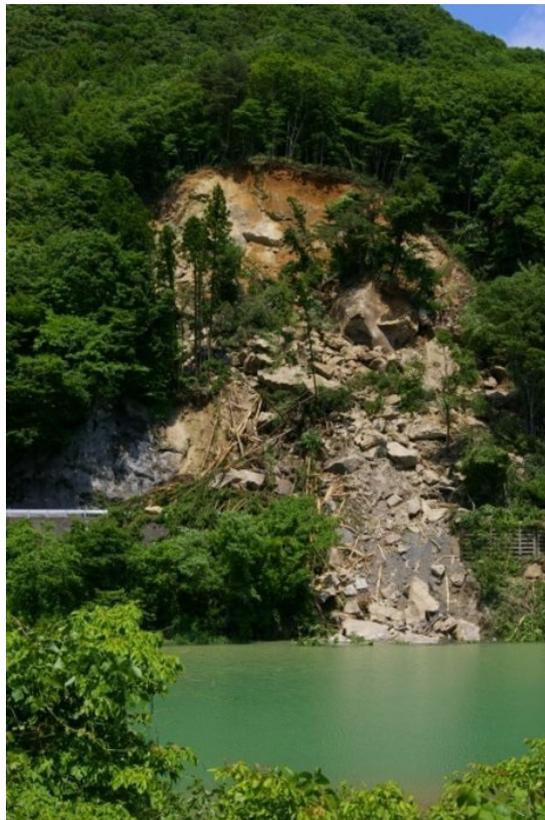
The Iwate-Miyagi Nairiku Earthquake

In this landscape carved by rivers, a landslide with an average depth of 55 meters, a width of 810 meters, and a length of 1400 meters slid as far as 140 meters off the side of the mastiff and into the back of the lake formed by the dam.

A few days after the earthquake, Tokyo University Professor Konagai Kazuo appeared on NHK television's "Close-up Gendai" special, "The Mountain that Disappeared: The Iwate-Miyagi Nairiku Earthquake," and explained that because ground water near the dam was high and because snowmelt had permeated the ground, the violent shaking of the earthquake had caused the massive landslide.

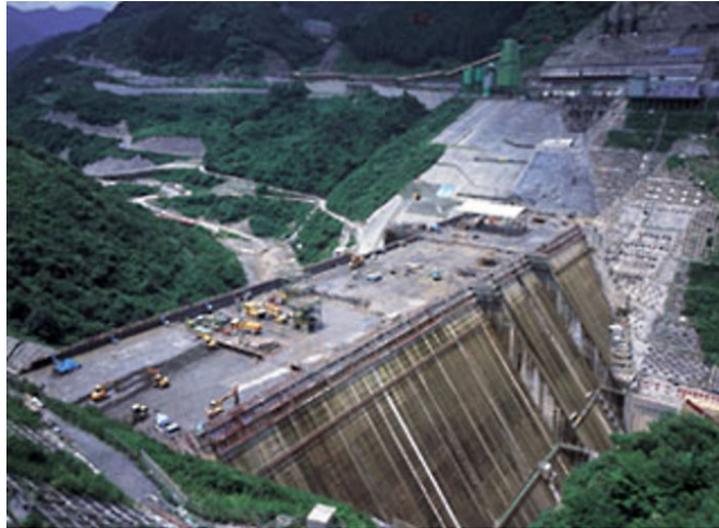
**Takizawa Dam, second construction**

In August 2006, soon after those measures ended, workers began to fill the reservoir again. In May 2007, the slope right next to the one that had been strengthened collapsed when the water level was 16 meters away from being full. A half month later, the slope—now 90 meters wide, 90 feet deep, and 15 meters long—slid further. In response, Kurihara Yoshiharu, the assistant director of the agency announced, “We knew that this was an area susceptible to landslides and while keeping the water level down, we had taken preventive measures such as constructing an embankment.” A visit to the area confirms evidence that the agency had taken all sorts of measures in no less than 40 different places. The agency had “combined the best construction techniques,” said Kurihara, yet this was insufficient.

Prevention measures continued and in August 2007 another attempt was made to fill the reservoir. This time, workers were able to fill it to capacity, but as they began to lower the water in April 2008, a crack was discovered in a city road near the reservoir bank. As the water continued to be lowered, other fissures appeared. On 7 May, a 40 centimeter diameter crack was found on Route 140 on the other side of the reservoir and six days later another was discovered in a concrete barrier. Even when the water level was maintained, the land continued to slump. On 13 June, a crack appeared in another city road as the slope dropped by .4 meters. When I visited Saitama, a worker put it bluntly: “A mountain is moving here.” It was an obvious disaster.

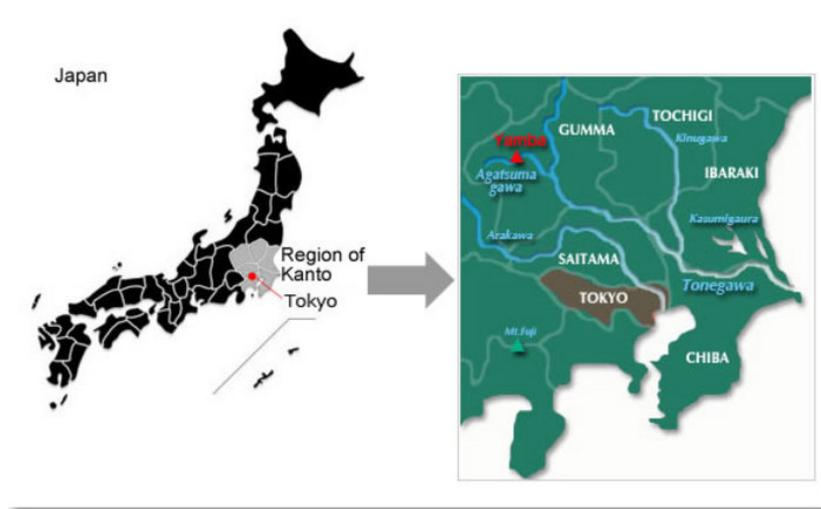
Yamba Dam map

The Transportation Ministry has designated the slopes around the reservoir site as susceptible to landslides and determined that 22 locations are likely to weaken when the reservoir is filled. In the end, however, the ministry decided to take preventive measures in just six spots “where stored water is highly likely to lead to landslides.” The region around the dam has been repeatedly subject to volcanic activity, and, as is even reported on the Transportation Ministry's website, it is the location of a hydrothermally-altered zone. Areas that have such a zone and experience other volcanic activity are particularly vulnerable to landslides.
